CRASH RESEARCH & ANALYSIS, INC.

ON-SITE AMBULANCE CRASH INVESTIGATION

SCI CASE NO: CR12002

VEHICLE: 2011 FORD E350 CHASSIS

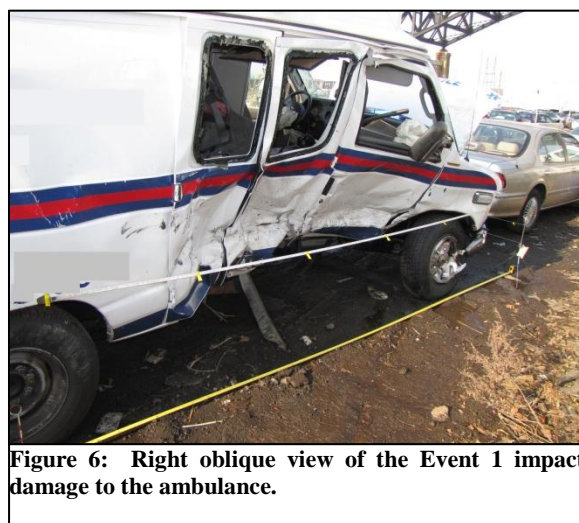
The ambulance sustained direct and induced damage to the right, left, front and back planes as a result of the multiple event crash. The Event 1 direct damage measured 249 cm (98.0 in) and extended along the right plane from a point 74 cm (29.0 in) forward of the right rear axle to a point on the right front wheel rim located 323 cm (127.0 in) forward of the rear axle reference. **Figure 6** is a right oblique view of the damage. The Field L (direct plus induced damage) measured 358 cm (141.0 in) and began 13 cm (5.2 in) forward of the rear axle. The lateral impact crushed the right plane, deformed the right frame member and separated the drive shaft. The right wheelbase was reduced 11 cm (4.2 in) as a result of the frame deformation. The residual crush profile was as follows: C1 = 0, C2 = 14 cm (5.5 in), C3 = 42 cm (16.5 in), C4 = 48 cm (18.9 in), C5 = 24 cm (9.5 in), C6 = 0. The maximum crush was at C4 which was located adjacent to the right B-pillar. This damage pattern extended to a height of 104 cm (41.0 in) above the ground. The total delta-V of the

Figure 6: Right oblique view of the Event 1 impact damage to the ambulance.

ambulance calculated by the Damage algorithm of the WinSMASH program was 22 km/h (14 mph), with longitudinal and lateral components of -11 km/h (-7 mph) and -19 km/h (-12 mph), respectively. These results were considered to be low. The Collision Deformation Classification (CDC) assigned to this damage pattern was 02RYEW4.

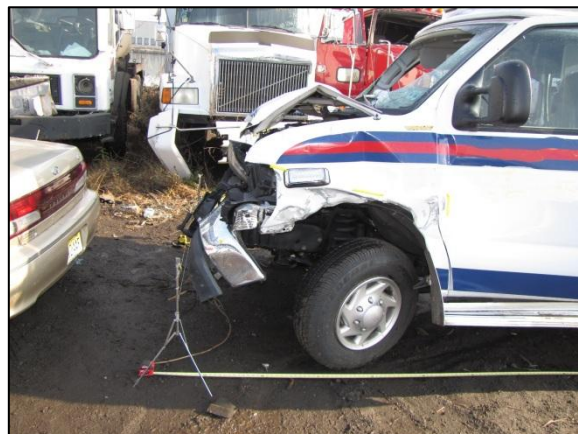
The impact damage related to Event 3 was located on the forward left plane (**Figure 7**) and across the front plane of the ambulance (**Figure 8**). The contact damage to the left plane measured 103 cm (40.5 in) in length and was located on the left fender 308 cm to 409 cm (121.5 in to 161.0 in) forward of the left rear axle. The height of the damage measured 97 cm (38 in) above the ground. The damage consisted of sheet metal abrasions and lateral deformation to the fender measuring less than 3 cm (1 in) in greatest depth. Although the contact was located above the left front axle, the wheel assembly did not exhibit damage. The left wheelbase measurement was not changed. This damage pattern appeared to wrap around the left front corner and extend across the front plane. The damaged components included the chrome front bumper, plastic grill, headlamp assemblies, and hood. There was no crush or deformation to the upper radiator support. The face of the front bumper was rotated to a near vertical orientation. The direct contact at the bumper elevation began 66 cm (26 in) left of center and extended 155 cm (61 in) to the front right corner. The residual crush profile was as follows: C1 = 0, C2 = 6 cm (2.5 in), C3 = 18 cm (7.0 in), C4 = 24 cm (9.5 in), C5 = 27 cm (10.5 in), C6 = 33 cm (13.0 in). This CDC was 12FDEW2.

Figure 7: View of the ambulance's left fender damage.

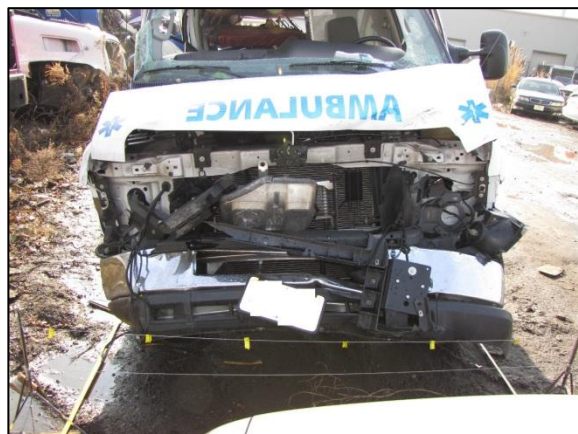
Figure 8: Front view of the ambulance.

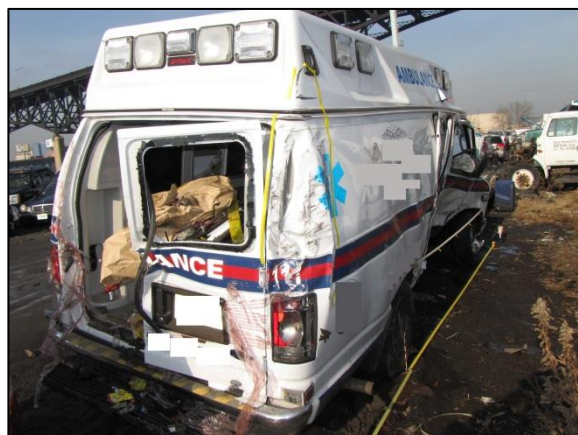
Figure 9: Right rear oblique view of the Event 4 ambulance damage.

the extreme right corner and buckled the right plane forward. This damage pattern (**Figure 9**) was consistent with a non-horizontal impact to the back plane during its contact with the Chrysler. The ambulance was rolled to its right and partially supported by the Chrysler. Black scuff marks were noted to the right side plane of the ambulance from contact with the Chrysler's roof rack. This damage pattern was isolated to the right corner and measured 30 cm x 122 cm (12 in by 48 in), width by height. It was began 86 cm (34 in) above the ground and extended to 208 cm (82 in) above the ground reference. The CDC assigned to this damage pattern was 00BRHE2.

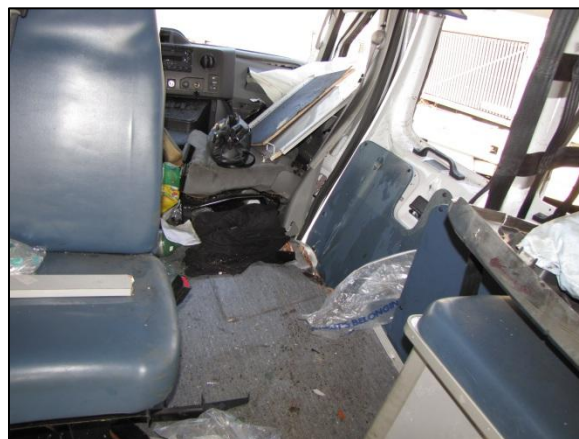
The lateral impact buckled the right double doors inward and buckled the floor vertically (**Figure 11**). The intrusion of the doors measured 15 cm

Figure 11: View depicting the right double door and floor intrusion of the patient compartment.

(6 in) at the elevation of the belt line. The vertical buckling of the floor measured 19 cm (7.5 in). The lateral cabinet/shelf that housed the air conditioner (above the pass-through) fractured due to the compressive load of the impact (**Figure 12**). The vertical cabinet located between the Captain's seat and the driver seat was displaced downward. The right wall aft of the doors, the inward-facing bench seat and the left interior wall/cabinetry was undamaged.

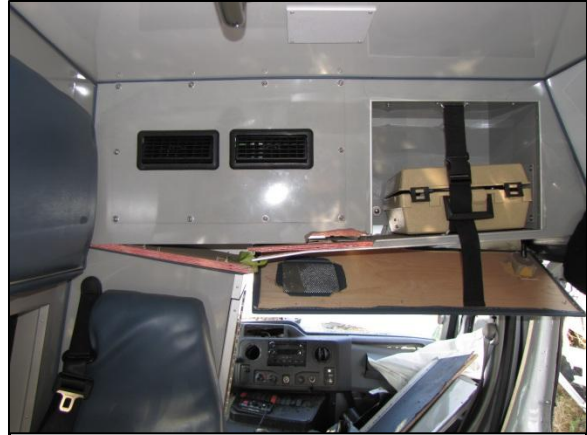
Figure 12: View depicting the fractured cabinet/shelf above the patient compartment pass-through.

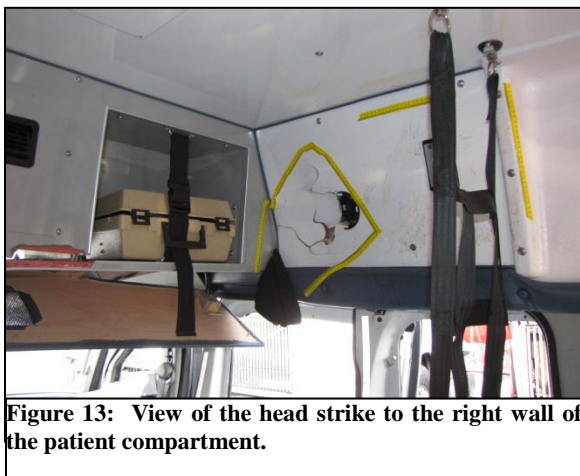
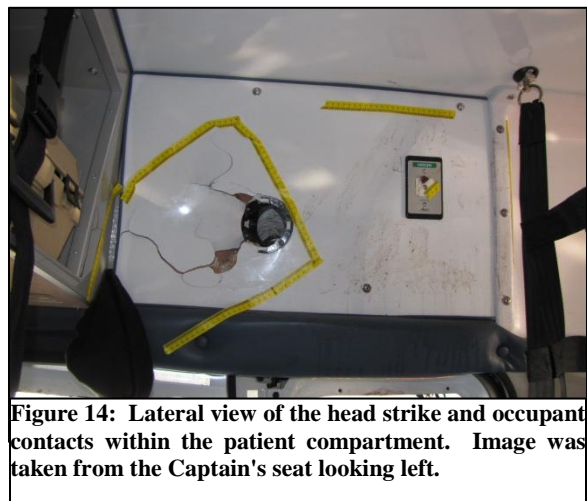
A head strike with pocketing was observed on the right wall of the patient compartment immediately above the double doors (**Figures 13 and 14**). This occupant contact was directly to the left of the Captain's seat (was respect to the rear-facing occupant) and was in-line with the direction of the Event 1 impact force. The fracture site measured 33 cm x 33 cm (13 in x 13 in). The EMT's knit hat was found snagged on the fractured wall panel and hair strands were observed within the fracture site. Adjacent to the head strike, at the O2 port, was body matter and a 41cm x 36 cm (16 in x 14 in) area of blood.

Figure 13: View of the head strike to the right wall of the patient compartment.

Figure 14: Lateral view of the head strike and occupant contacts within the patient compartment. Image was taken from the Captain's seat looking left.

The force of the Event 1 impact displaced the unrestrained EMT from the seat. He responded to the lateral direction of the impact force with a right trajectory (with respect to the ambulance). The EMT impacted the right wall with his head as evidenced by the identified fracture. Hair strands were observed embedded within the fracture site and his knit hat was still snagged in the fractured laminate of the wall panel. This impact resulted in the reported blunt force head trauma.

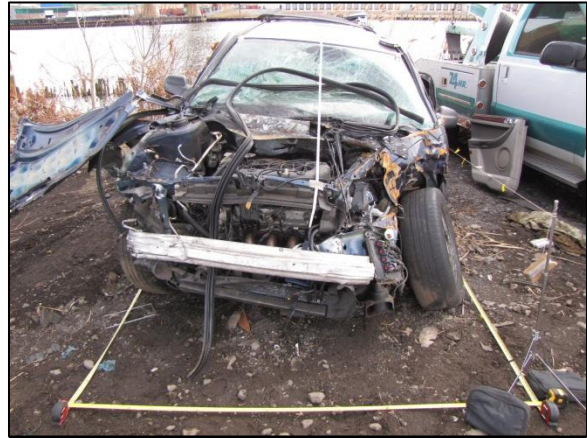
Figure 19: Front view of the Chrysler.

The front plane sustained direct contact damage across the entire 152 cm (60 in) end width (**Figure 19**). The vehicle-to-vehicle interaction separated the fascia, bumper reinforcement bar and the sub-structures forward of the radiator support plane. [Note, the bumper reinforcement bar was found inside the ambulance and was placed onto the Chrysler for photo documentation purposes.] The front structure of the vehicle was deformed 33 cm (13 in) to the right - measured with respect to the projected original centerline. Residual crush was documented at the deformed left and right frame rail ends and measured 36 cm (14 in) and 46 cm (18 in), respectively. The delta-V of the initial impact calculated by the WinSMASH Damage Algorithm was 43 km/h (27 mph). The longitudinal and lateral components were -33 km/h (-21 mph) and 27 km/h (17 mph), respectively. The results were considered low. The CDC assigned to the Event 1 damage was 71FDEW2. (The 11 o'clock direction of force was incremented to account of the right lateral end shift.)

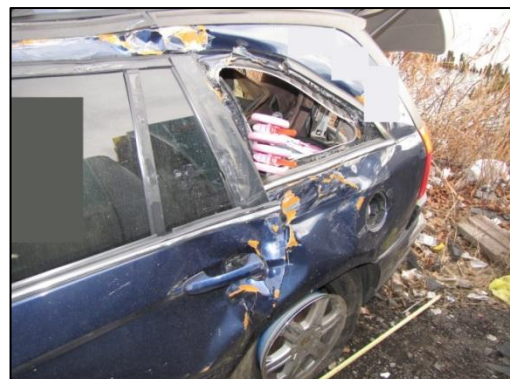
The center and aft aspect of the left plane sustained a region of direct contact damage (**Figure 20**) that began on the left roof side rail 86 cm (34 in) forward of the left rear axle. Abrasions were noted to the left ends of the roof racks and related to the black scuff marks observed on the right side of the ambulance. The height of this contact measured 150 cm (59 in) above the ground. The damage pattern extended rearward and

Figure 20: View depicting the damage located at the Chrysler's left plane/aft aspect.

down along the left plane ending 38 cm (15 in) aft of the rear axle reference. This damage related to the non-horizontal impact with the back plane on the ambulance, (Event 4). The CDC was 00LZAW3.

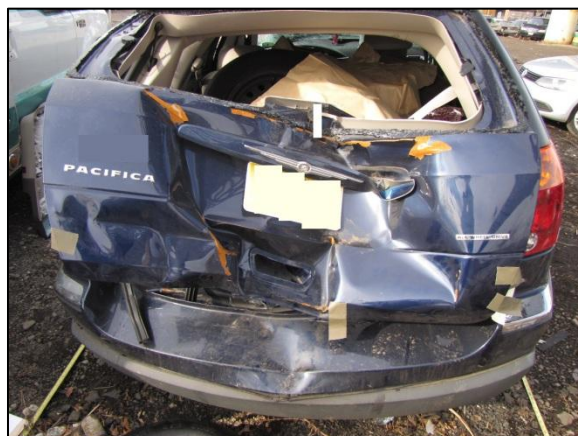
The Chrysler's back plane damage was located at its center and left aspects (**Figure 21**). This damage resulted from the Event 6 impact with the Ford bus. The rear bumper damage was concealed by the fascia which hampered documentation. The direct contact damage began 18 cm (7 in) right of center and ended 51 cm (20 in) left of center. The maximum crush was an estimated 8 cm (3 in). The left gate was crushed forward at its center aspect. The CDC assigned to this damage pattern was 06BYEW2. Examination of the engine compartment revealed that a small engine compartment fire developed (Event 7). Observation and inspection determined that the origin of the fire appeared to be electrical and was subsequently fuel fed. Fire damage was limited to the right engine compartment in the area surrounding the alternator.

Figure 21: Rear view of the Chrysler.

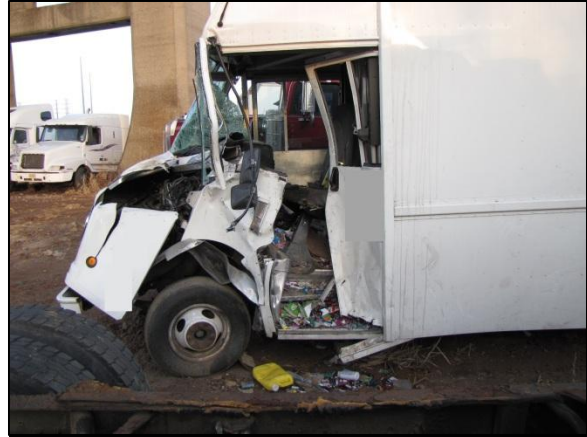
The left plane of the van exhibited a region of direct contact damage that was located from the B-pillar (trailing edge of the left door) extending 198 cm (78 in) forward to the left fender area above the front axle (**Figure 23**). The lateral extent of the deformation measured approximately 64 cm (25 in). This value did not represent a crush measurement; rather it was representative of the displacement of the side panel and the depth of the maximum vehicle-to-vehicle engagement. The purpose of the body panel was cosmetic and functional; it was not designed for true crashworthiness. The center of the impact region was located at the plane of the instrument panel and engine cowl. The force of the impact displaced the instrument panel 18 cm (7 in) to the right. The steering wheel assembly fractured and separated from the upper aspect of the steering column. The left door separated from its sliding tracks and cantilevered inward into the driver's occupant space. The floor pan buckled vertically in the area of the foot controls. The Truck Deformation Classification was 09LYAW3.

Figure 23: Left side view of the direct damage to the Workhorse.
